**SPRING LAKE DAM**

Missouri Inventory No. 30725

**Phase I Inspection Report**

**National Dam Safety Program**

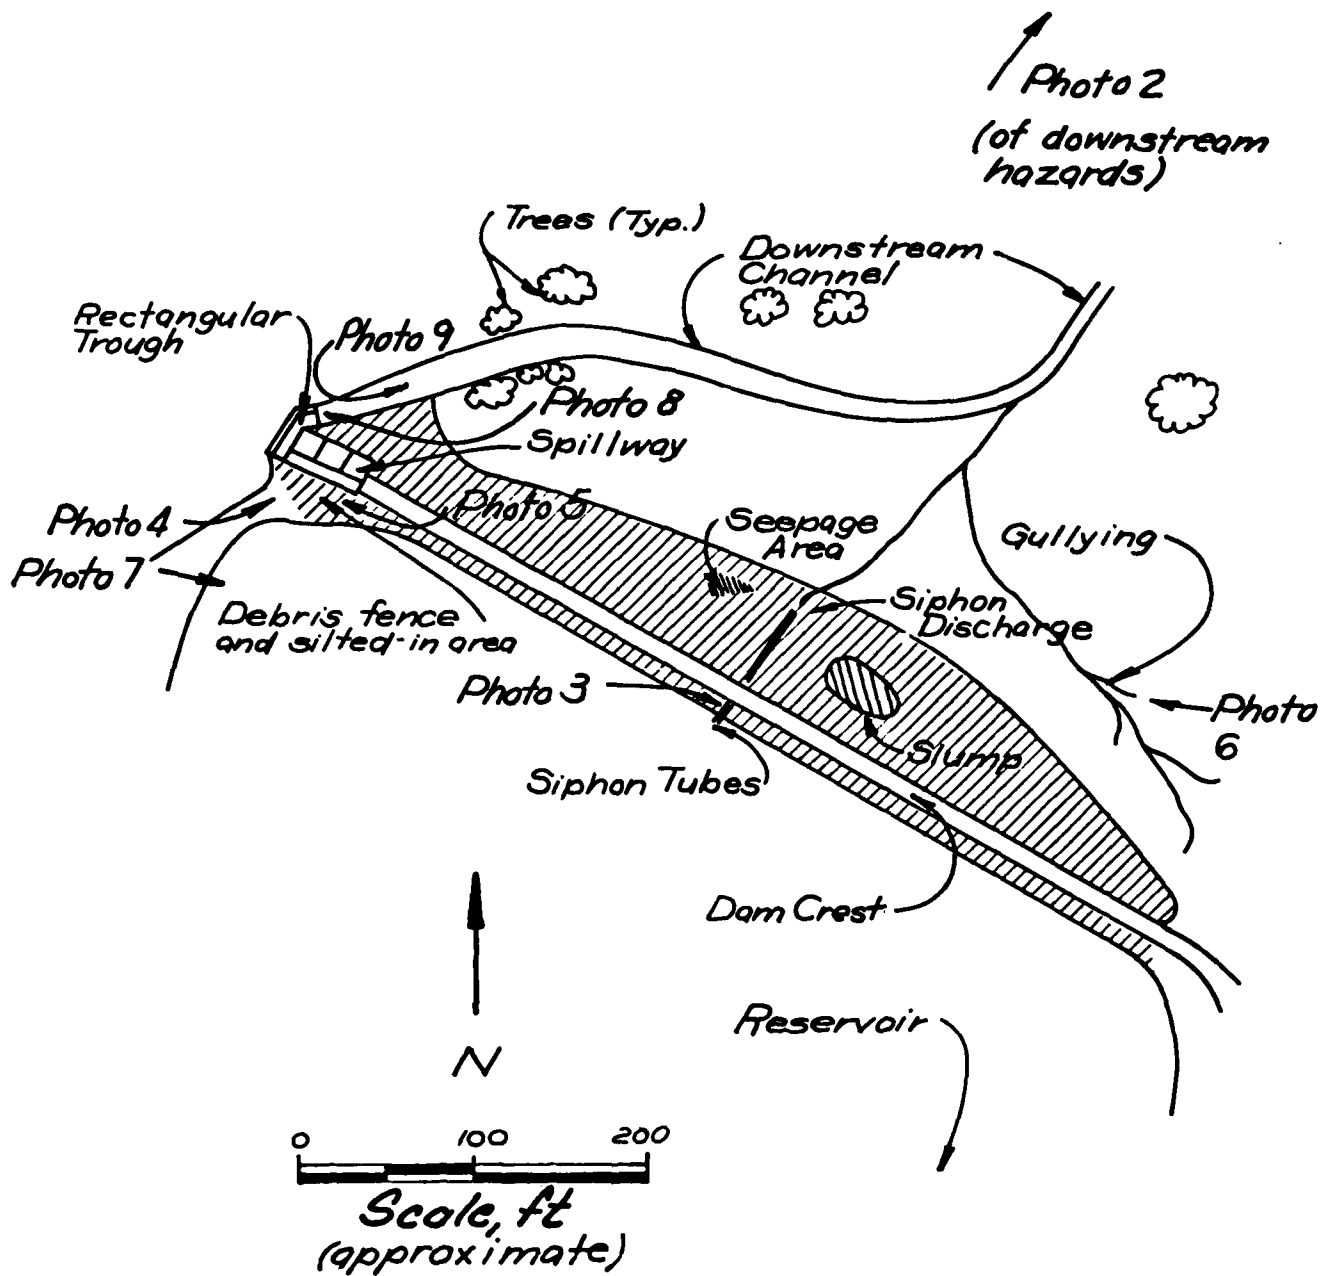
Fig. A-1

Minor seepage was found in the area of the toe (Figure A-1, Appendix A), but evidence of piping was not found in this area. Seepage seen in the downstream spillway channel is, in our opinion, a natural spring from the hillside and not from reservoir seepage.
